Australian Shipowners Association

**Assessment of Introduced Marine Pest
Risks Associated with Niche Areas in
Commercial Shipping**

Final Report

JANUARY 2007

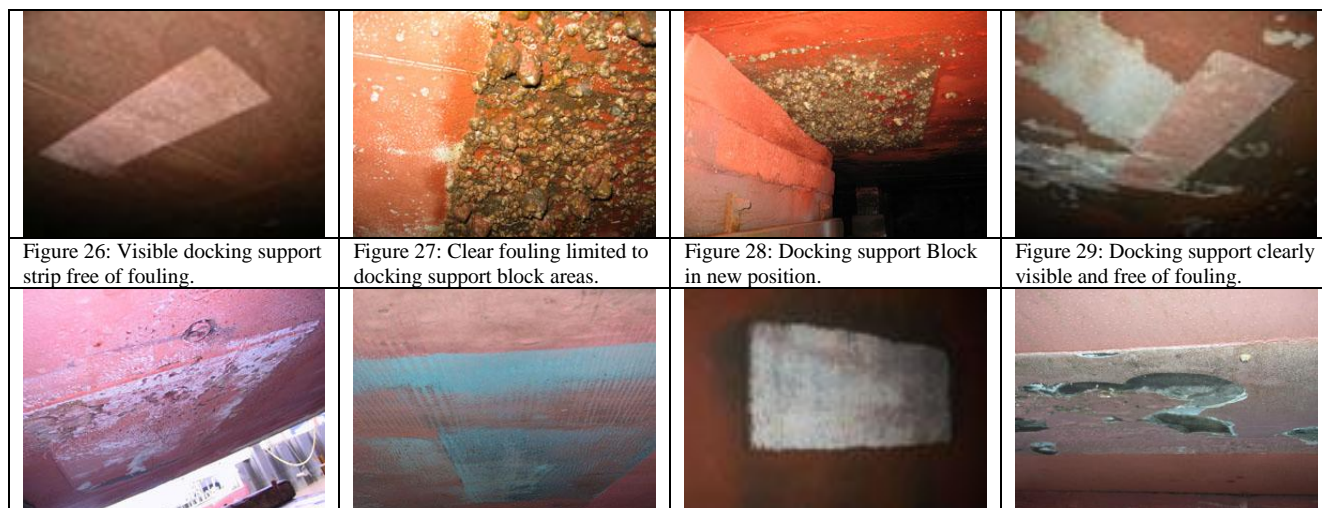
Docking support strips were evident on all ships observed. Overall however, these areas were clean and free of fouling.

Figure 30: Docking support block requiring antifouling treatment.	Figure 31: Docking support strip visible and free of fouling.	Figure 32: docking support strip clearly visible and free of fouling.	Figure 33: Paint on docking support strip in need of treatment.
---	---	---	---
